**STATE CORONER'S COURT  
OF NEW SOUTH WALES**

<b>Inquiry:</b>	Inquiry into the Fire at Springwood NSW 17 October 2013 And the Fire at Mt Victoria NSW 17 October 2013
<b>Hearing dates:</b>	1-5 June 2015, 24-28 August 2015, 7 -9 December 2015, 31 October 2017 – 1 November 2017
<b>Date of findings:</b>	23 May 2018
<b>Place of findings:</b>	NSW Coroners Court - Katoomba
<b>Findings of:</b>	<b>Magistrate Fiona G Toose Coroner</b>
<b>Catchwords:</b>	CORONERS- General Fire Inquiry-Springwood, Cause and Origin. Mt Victoria, Cause and Origin.
<b>File number:</b>

**Cause of fire: The fire was ignited by the effects of arcing of electrical conductors after the impact by a tree at 108 Linksview Road Springwood**

**Cause of fire: The fire was caused by electrical arcing when a tree branch located on a property at 80-92 Mount York Road, Mt Victoria impacted with high voltage conductors, leading to the ignition of foliage on the ground.**

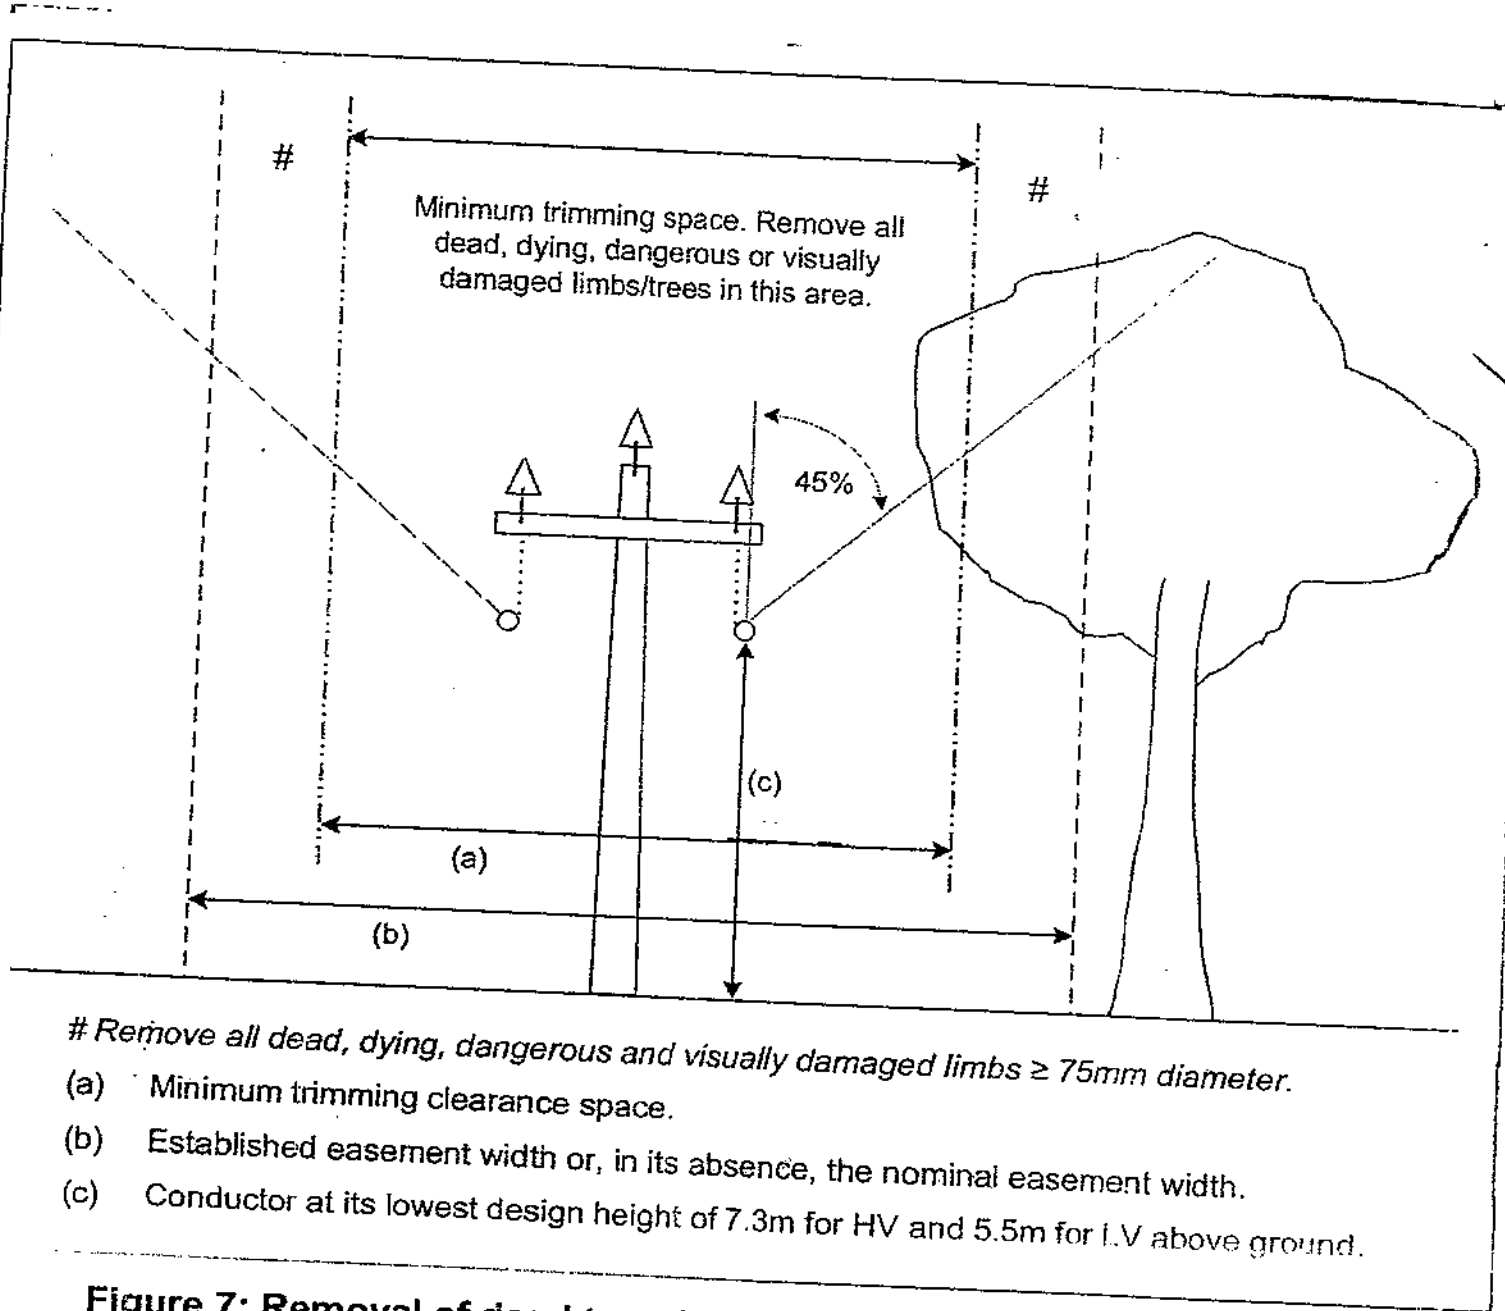
**Figure 7: Removal of dead trees/branches near overhead power lines**

“Particular attention is to be given to the likelihood of vegetation outside the clearance zone that may be dead or dying **and** at a height that, if failure occurred, impact to the overhead mains would result. Vegetation in this condition is to be reported for removal.”<sup>xlvii</sup> (emphasis added)

On the face of MMI0001, as it applied in 2013, this additional reporting and removal requirement would not apply to a tree of sufficient height to hit overhead mains if it failed, unless the tree also had signs that it was dead or dying. This appears to be a sensible approach, given that there must be many thousands (if not hundreds of thousands) of trees within Endeavour Energy regions that sit outside trimming clearances, but are tall enough to reach overhead mains if the tree falls.
