Report of the inquest  
into the deaths arising from the  
Thredbo landslide

**Derrick Hand**  
**Coroner**  
**29 June 2000**

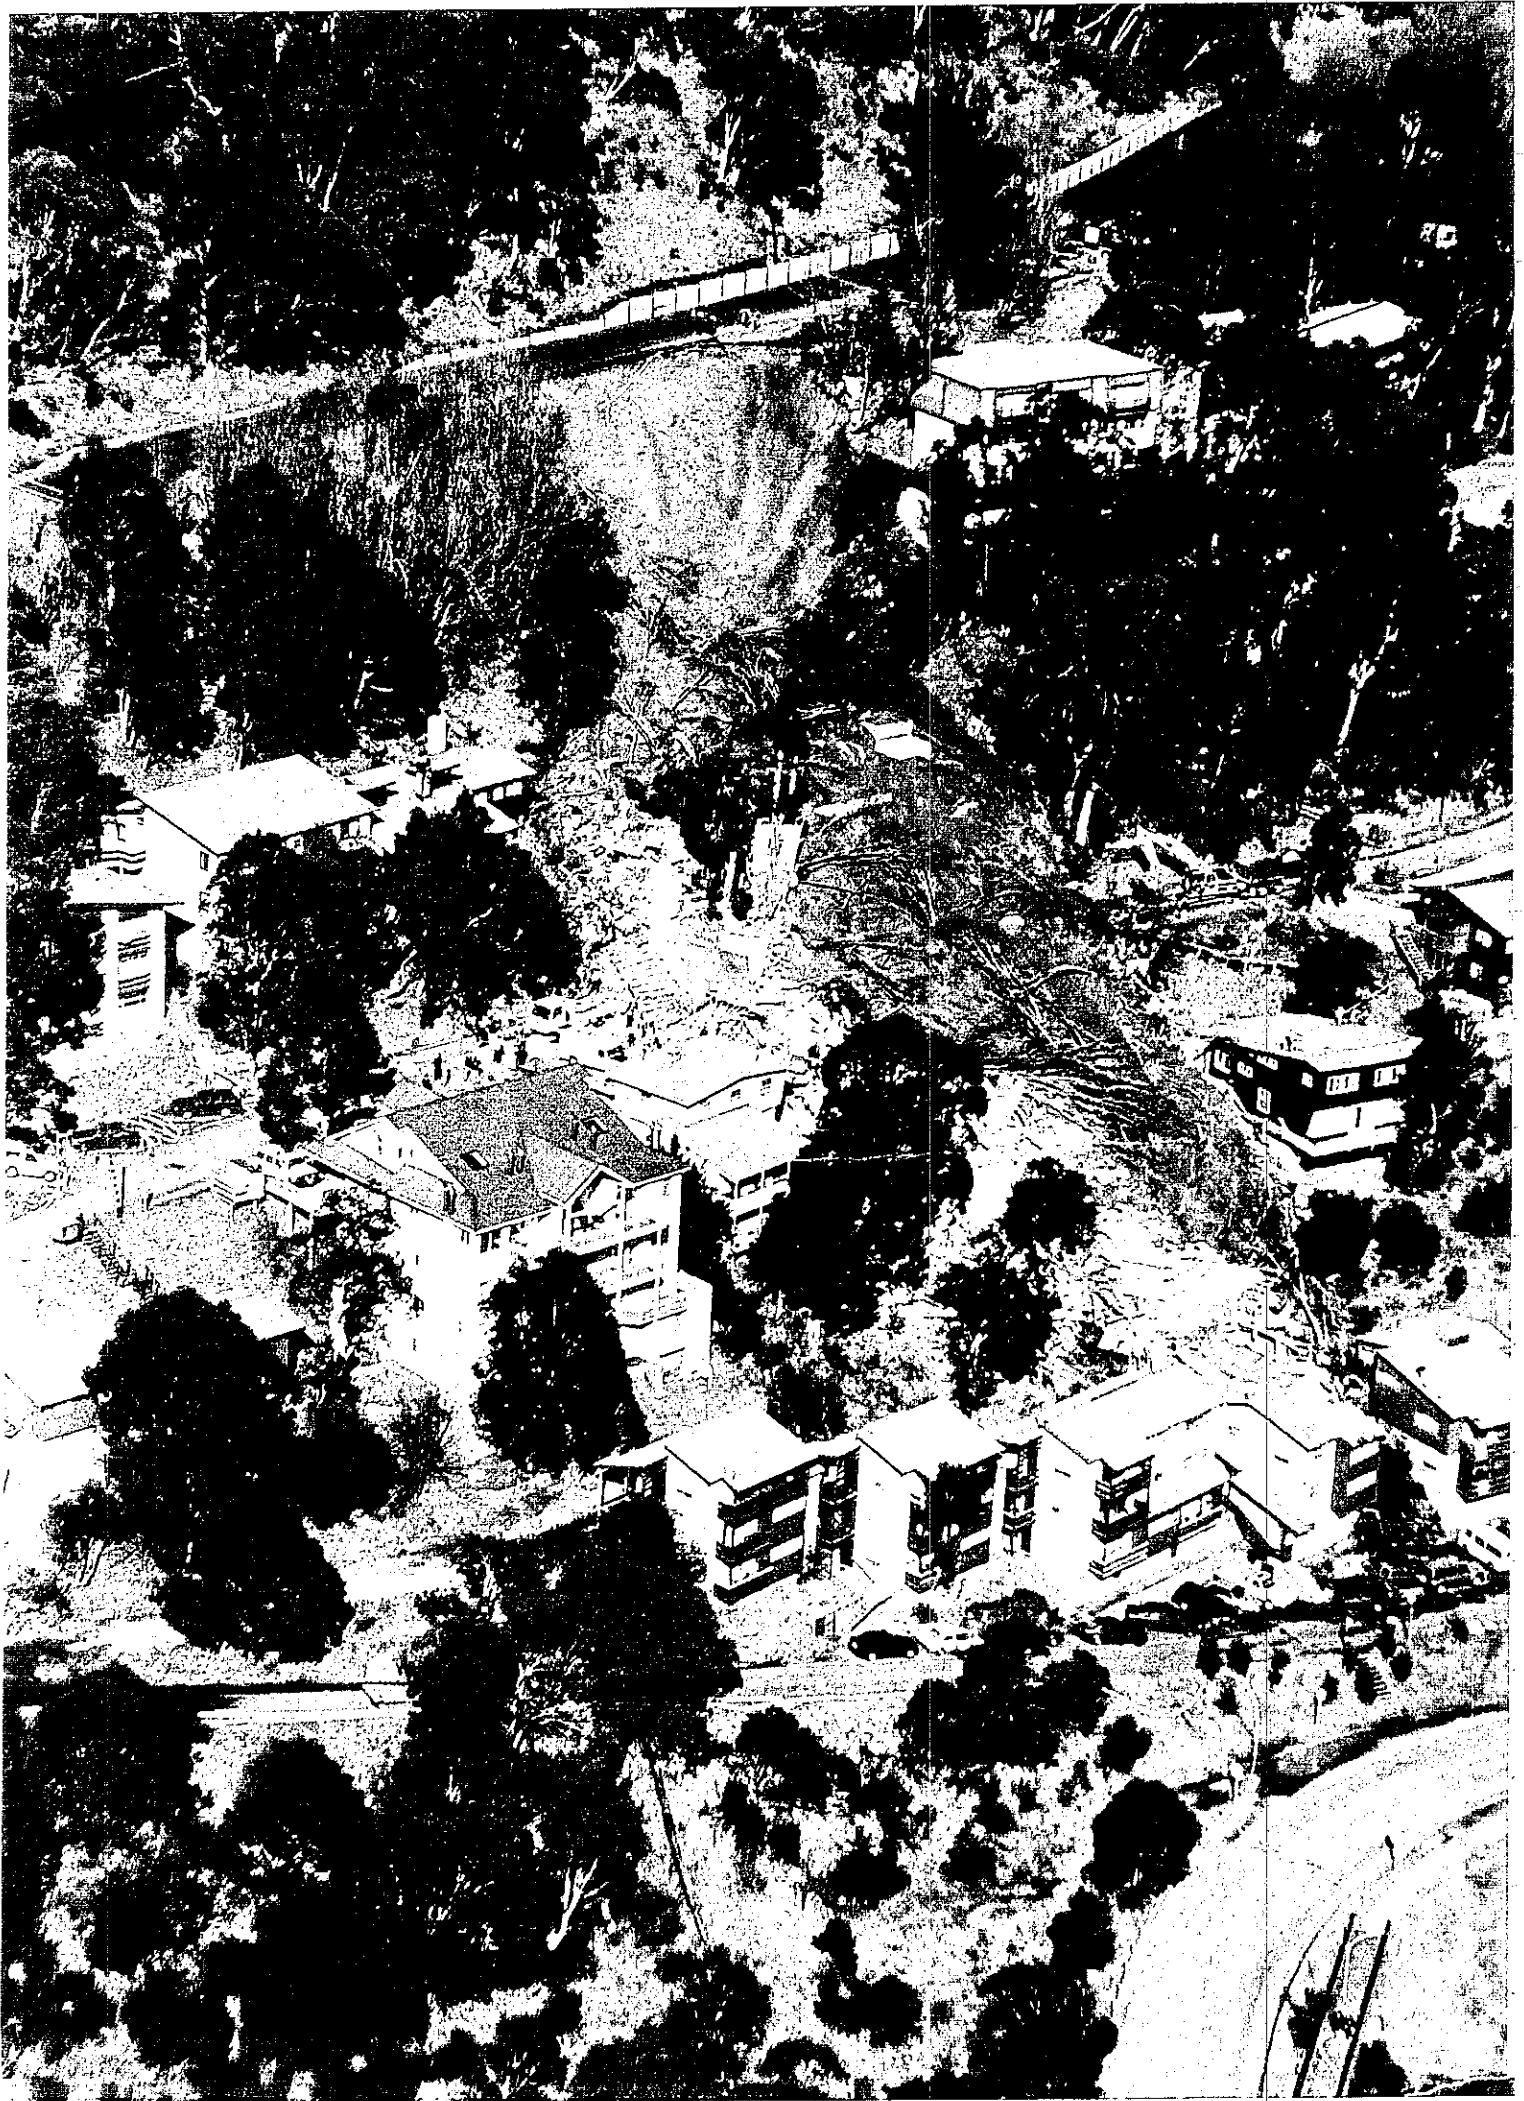
Fig 2. Aerial View of the Landslide

2. The movement of the landslide from the south-west to the north-east removed the support from the fill embankment of the Alpine Way to its south-east. It then collapsed. This second movement of the landslide moved in a north-westerly direction and impacted directly on the west wing of Carinya, shearing it from its foundations. The combined mass of the soil and the superstructure of the west wing of Carinya was projected down the slope across Bobuck Lane. It then impacted on the western end of Bimbadeen causing it to collapse and slewing the building in a clockwise direction. Eighteen people were in that lodge at the time.

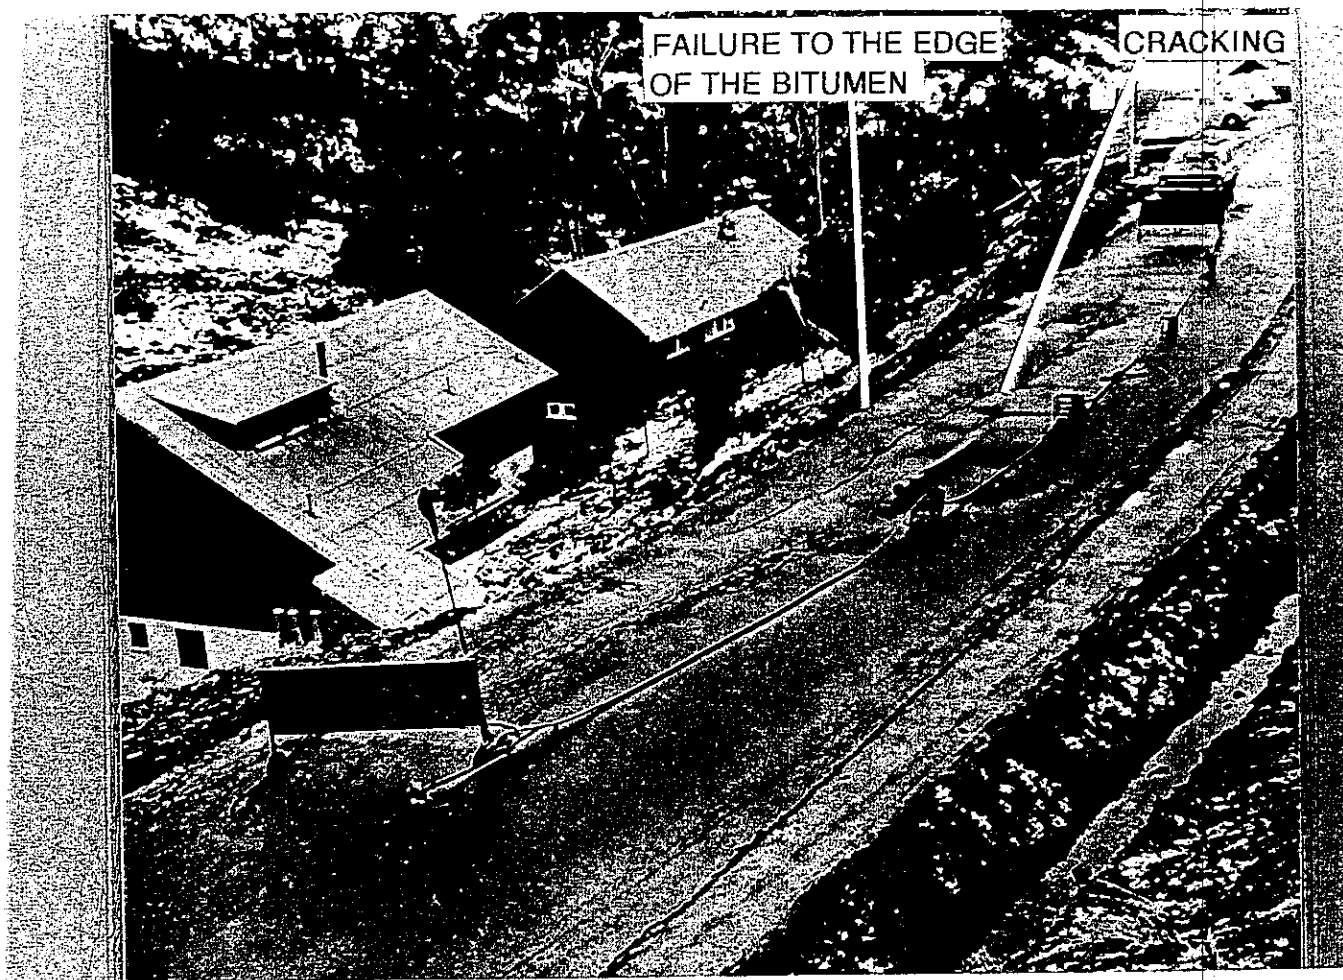
116. The Winterhaus landslide occurred on 2 October 1964. It involved the sudden slump of an outer segment of the fill on the Alpine Way above the Winterhaus Lodge through a vertical distance of about 6 feet. That slump was followed by a further vertical displacement to about 9 feet below the road pavement which occurred slowly over the following three days accompanied by a mudflow down-slope extension at the toe of the landslide. Prior to the landslide occurring, cracks and differential settlement of the pavement of the Alpine Way had developed. They were accompanied by several small isolated water outflows from the fill down-slope of the road (see Appendix 10, Figures 4 and 5).

- 2.2 1964 slide at chainage, 14.8 km in Thredbo Village.  
View to northeast of Winterhaus slide. Note cracking in pavement and loss  
of road to the edge of the bitumen.  
Photograph from SMHEA files.

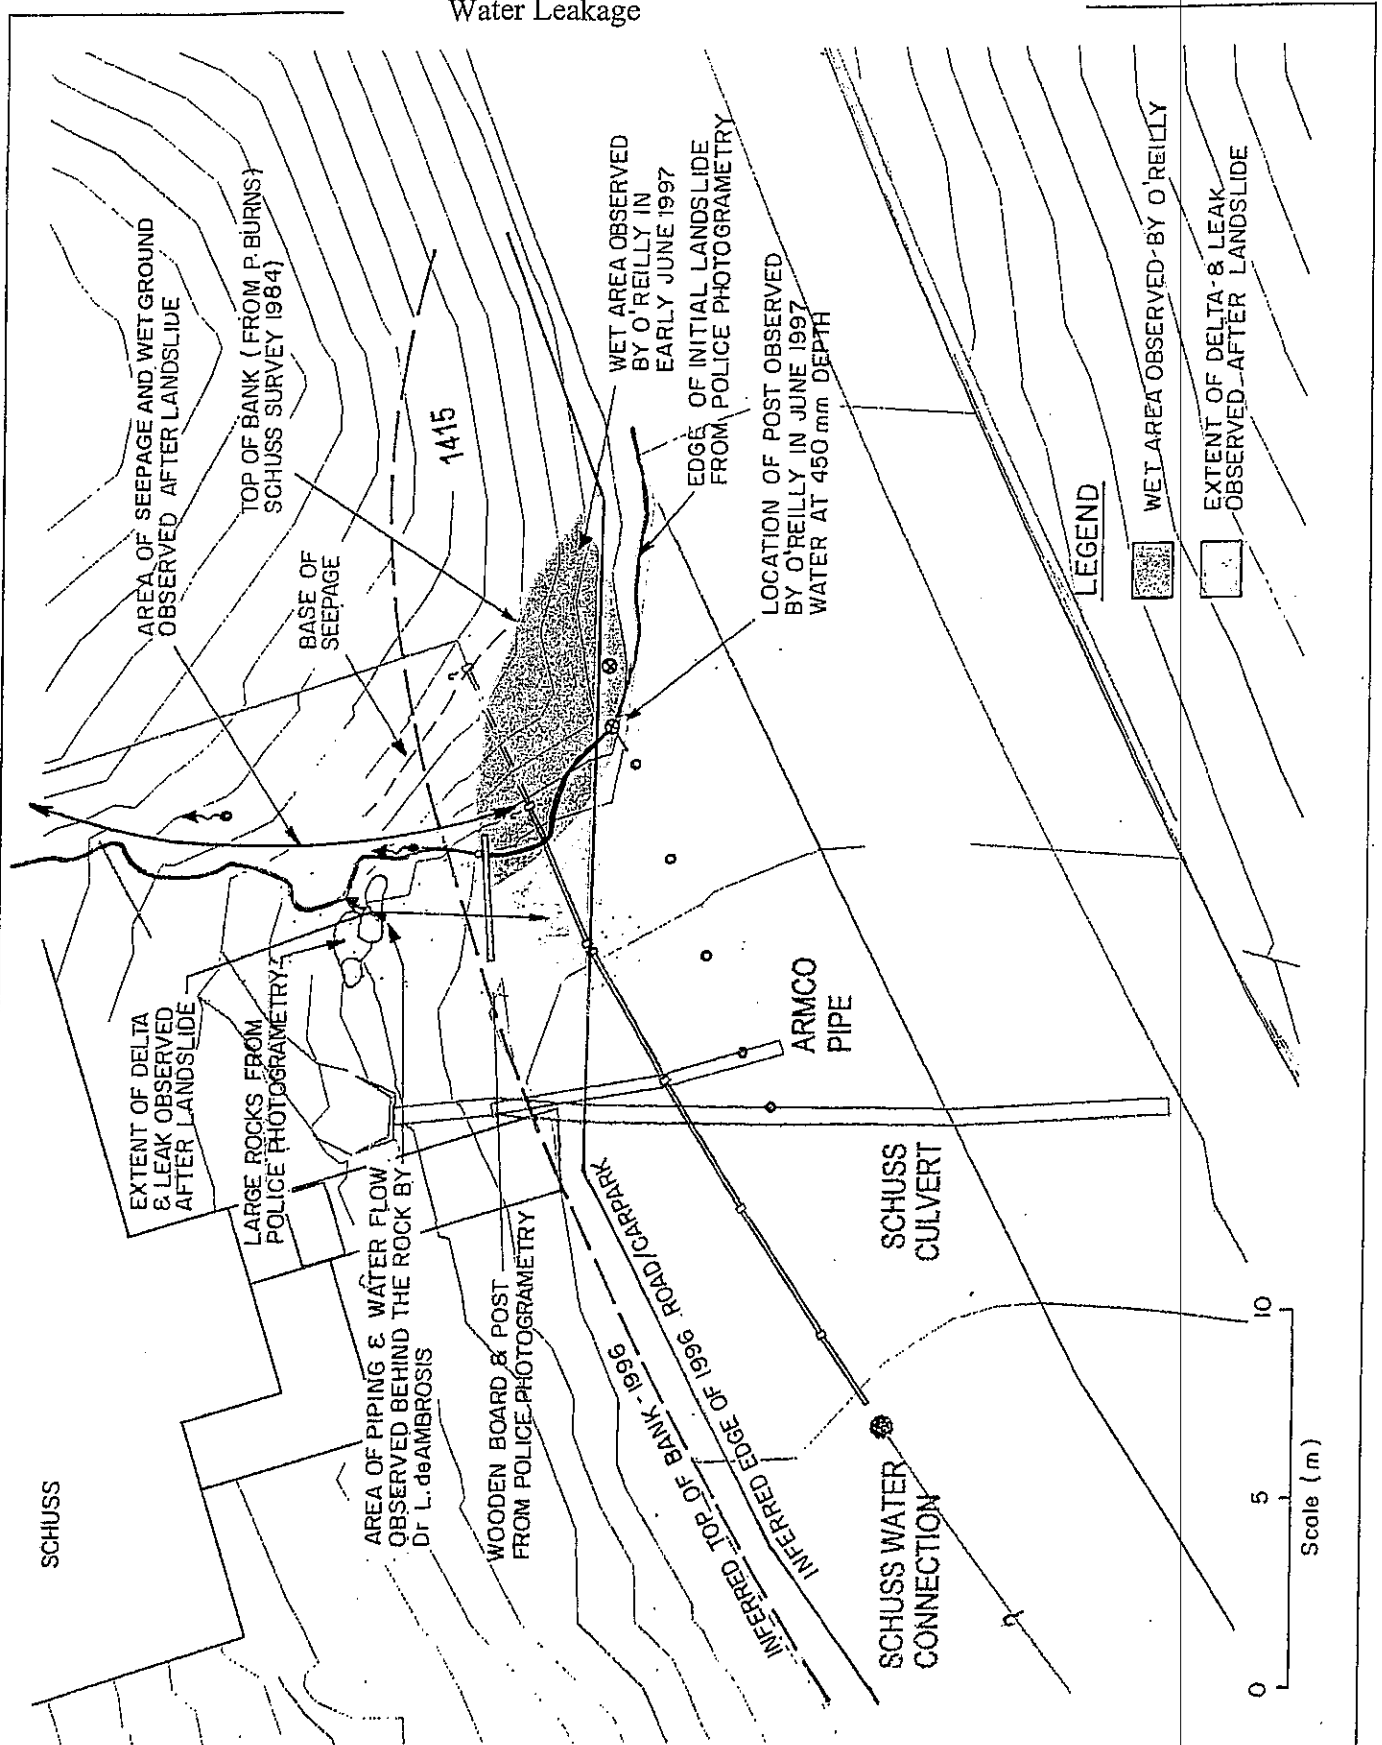
Fig 8. Location of Watermain and Observations of Water Leakage

4. I have found in this report that the landslide was triggered when water from a leaking watermain saturated the south-west corner of the landslide in the fill embankment of the Alpine Way setting off the first stage of the landslide. The first stage impacted upon the eastern wing of Carinya Lodge. Simultaneously the first stage removed the support of the land to its east causing that, too, to collapse onto the lodges below.

7. In the middle of the wet area in the south-west corner lay a fractured watermain pipe.
8. On the opposite side of the Alpine Way running the full length of the landslide scarp and beyond in both an easterly and westerly direction, was a retaining wall which had been constructed by NPWS in February-March 1997 (see Appendix 10, Figure 2).
