STATE CORONER'S COURT
OF NEW SOUTH WALES

Inquest:	Inquest into the death of Tyrone Marley Gilks
Hearing dates:	5,6 May and 9 July 2015
Date of findings:	10 July 2015
Place of findings:	Newcastle Local Court sitting as NSW State Coroner Court
Findings of:	Magistrate Michael Barnes, State Coroner
Catchwords:	CORONIAL LAW – Cause and manner of death; motorcycle long distance jumping; risk management; responsibilities of land-holder, local authority; NSW Sport and Recreation
File number:	2013/87599
Representation:	Sgt Harding assisting the State Coroner, Magistrate M. A. Barnes. Mr Ben Bickford, Barrister, I/B Mr Dane Twohill appearing on behalf of Ms Samantha Gilks Mr Paul Marr, Barrister, I/B Mr Michael Burke appearing on behalf of Mr Kevin Gilks

These are the findings of an inquest into the death of Tyrone Marley Gilks.

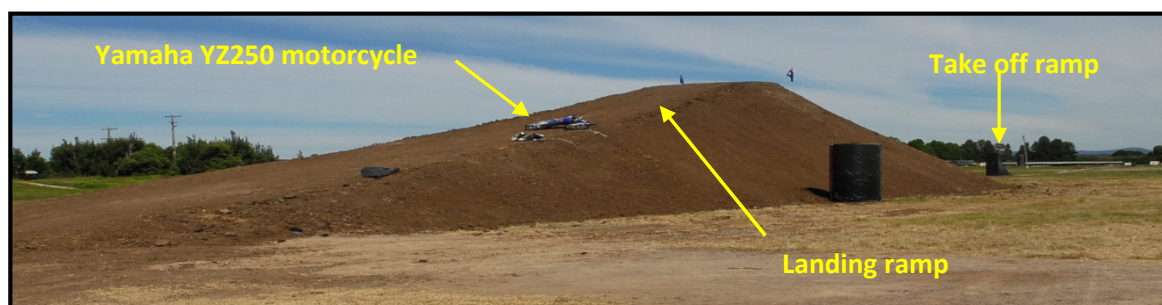
The ramp had a steep face leading to its apex approximately 7 metres above ground level. There was then a flat horizontal top approximately 4 metres long, referred to as the safety deck - the rider is not supposed to land on it but it will save him from crashing into the face of the ramp if he doesn't jump far enough. After the safety deck the ramp sloped gradually back down to ground level over 70 metres. The point where it begins to slope downwards is referred to as the knuckle and the distance between that point and the top of the take-off ramp is referred to as the gap distance. The "sweet spot" where the rider should try and land is in the upper half of that downward slope.

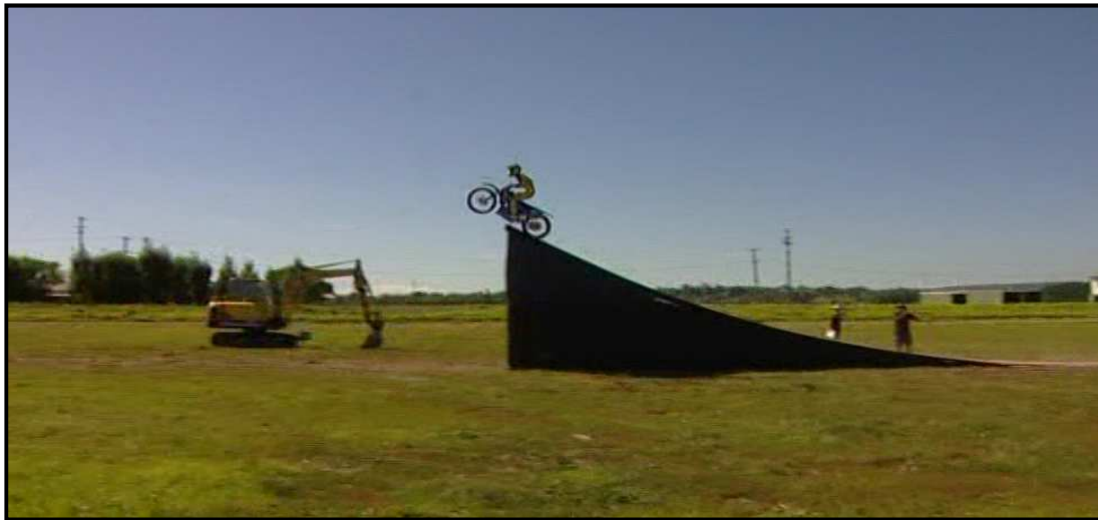
A take-off ramp that Mr Gilks had designed and had built some seven years before the fatality was erected in the arena on the area surrounded by the trotting track. Tyrone had used it on numerous previous occasions. It was about 3.6 metres high, 1.2 wide and 13.65 metres long and it launched the motorbike into the air at about a 28 degree trajectory. It was designed by consulting engineers. The picture below shows Tyrone riding over the ramp.

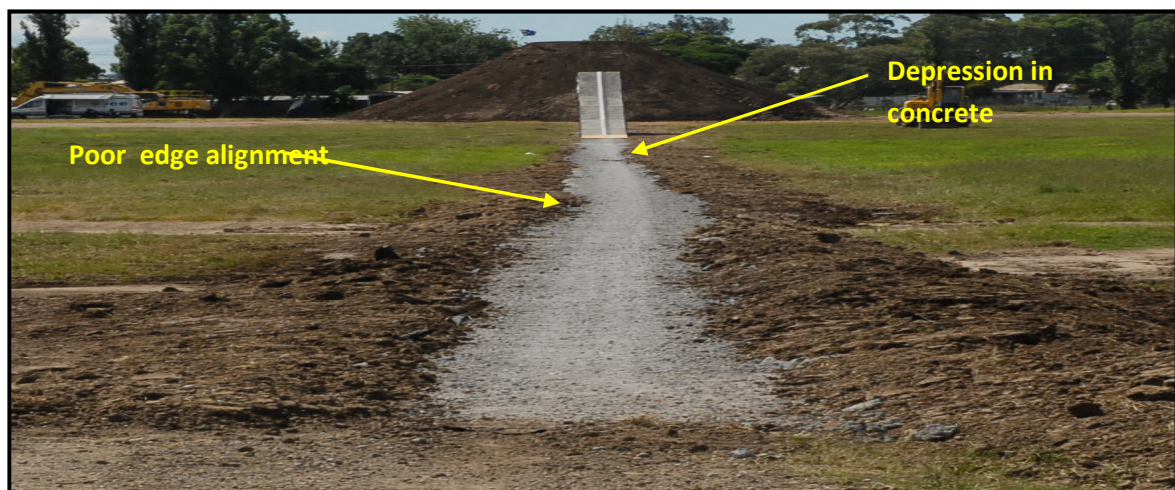
On Monday the 18 March 2013, he commenced to conduct practice runs and jumps at the arena. During these runs it was determined that the grass surface inside the trotting track on the lead up to the take-off ramp was not providing sufficient traction and this would hinder the attainment of the necessary speed. It was decided that it would be necessary to pour a concrete strip to overcome this. On Tuesday the 19 March 2013, this was done. It ran from where the path of the approach left the sealed road to the base of the take off ramp. It was 1.2 metres wide and 130 metres long. This concrete surface was quite rough, it had undulations, and it was not screeded and had a poor alignment. It is pictured below.

- c. The latter portion of the in-run was constructed of a poorly aligned, thin, rough and inconsistent un-screeded concrete strip which was clearly an afterthought and was prepared with poor execution.
