**CORONERS COURT
OF NEW SOUTH WALES**

Inquest:	Inquest into the death of Alan Beeby
Hearing dates:	12 - 14 September 2023
Date of findings:	14 September 2023
Place of findings:	Newcastle
Findings of:	Magistrate Kennedy Deputy State Coroner
Catchwords:	CORONIAL LAW – maritime safety, safety standards for recreational vessels, certification of recreational vessels, product warnings for recreational vessels, code of conduct for boat brokers, Boating Industry Association, Australian Recreational Boating Safety Committee, European Union design standards for recreational vessels, ISO Standards for recreational vessels, Australian Builders Plate standard, EPIRB functionality, Halvorsen motor yachts, certification of imported recreational vessels
File number:	2020/100125145
Representation:	Counsel Assisting the inquest: Mr Callan O'Neill of Counsel instructed by Mr Paul Armstrong of the NSW Crown Solicitors Office. Mrs Lorraine Beeby, Senior Next of Kin: Mr Gordon McGrath of Counsel instructed by Mr Julien Castaldi of Sparke Helmore Lawyers.

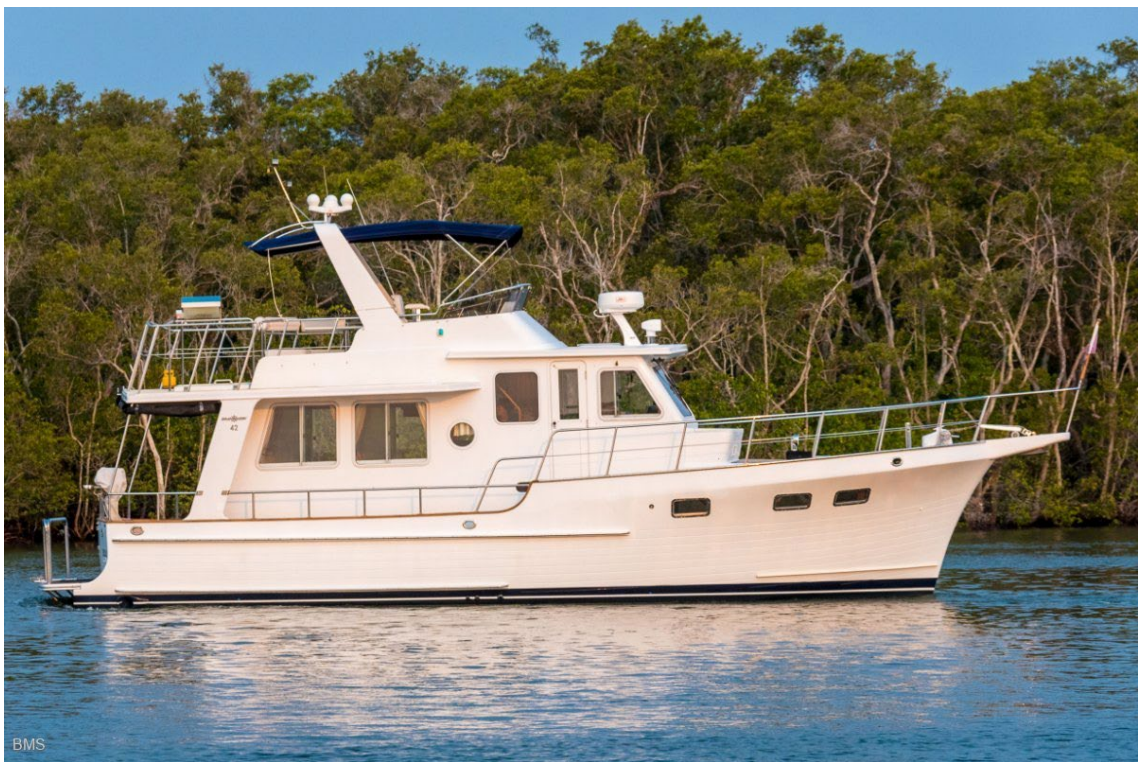
Photograph of 'Eliza 1' as advertised prior to its sale to Alan Beeby
