Report of the inquest  
into the deaths arising from the  
Thredbo landslide

**Derrick Hand**  
**Coroner**  
**29 June 2000**

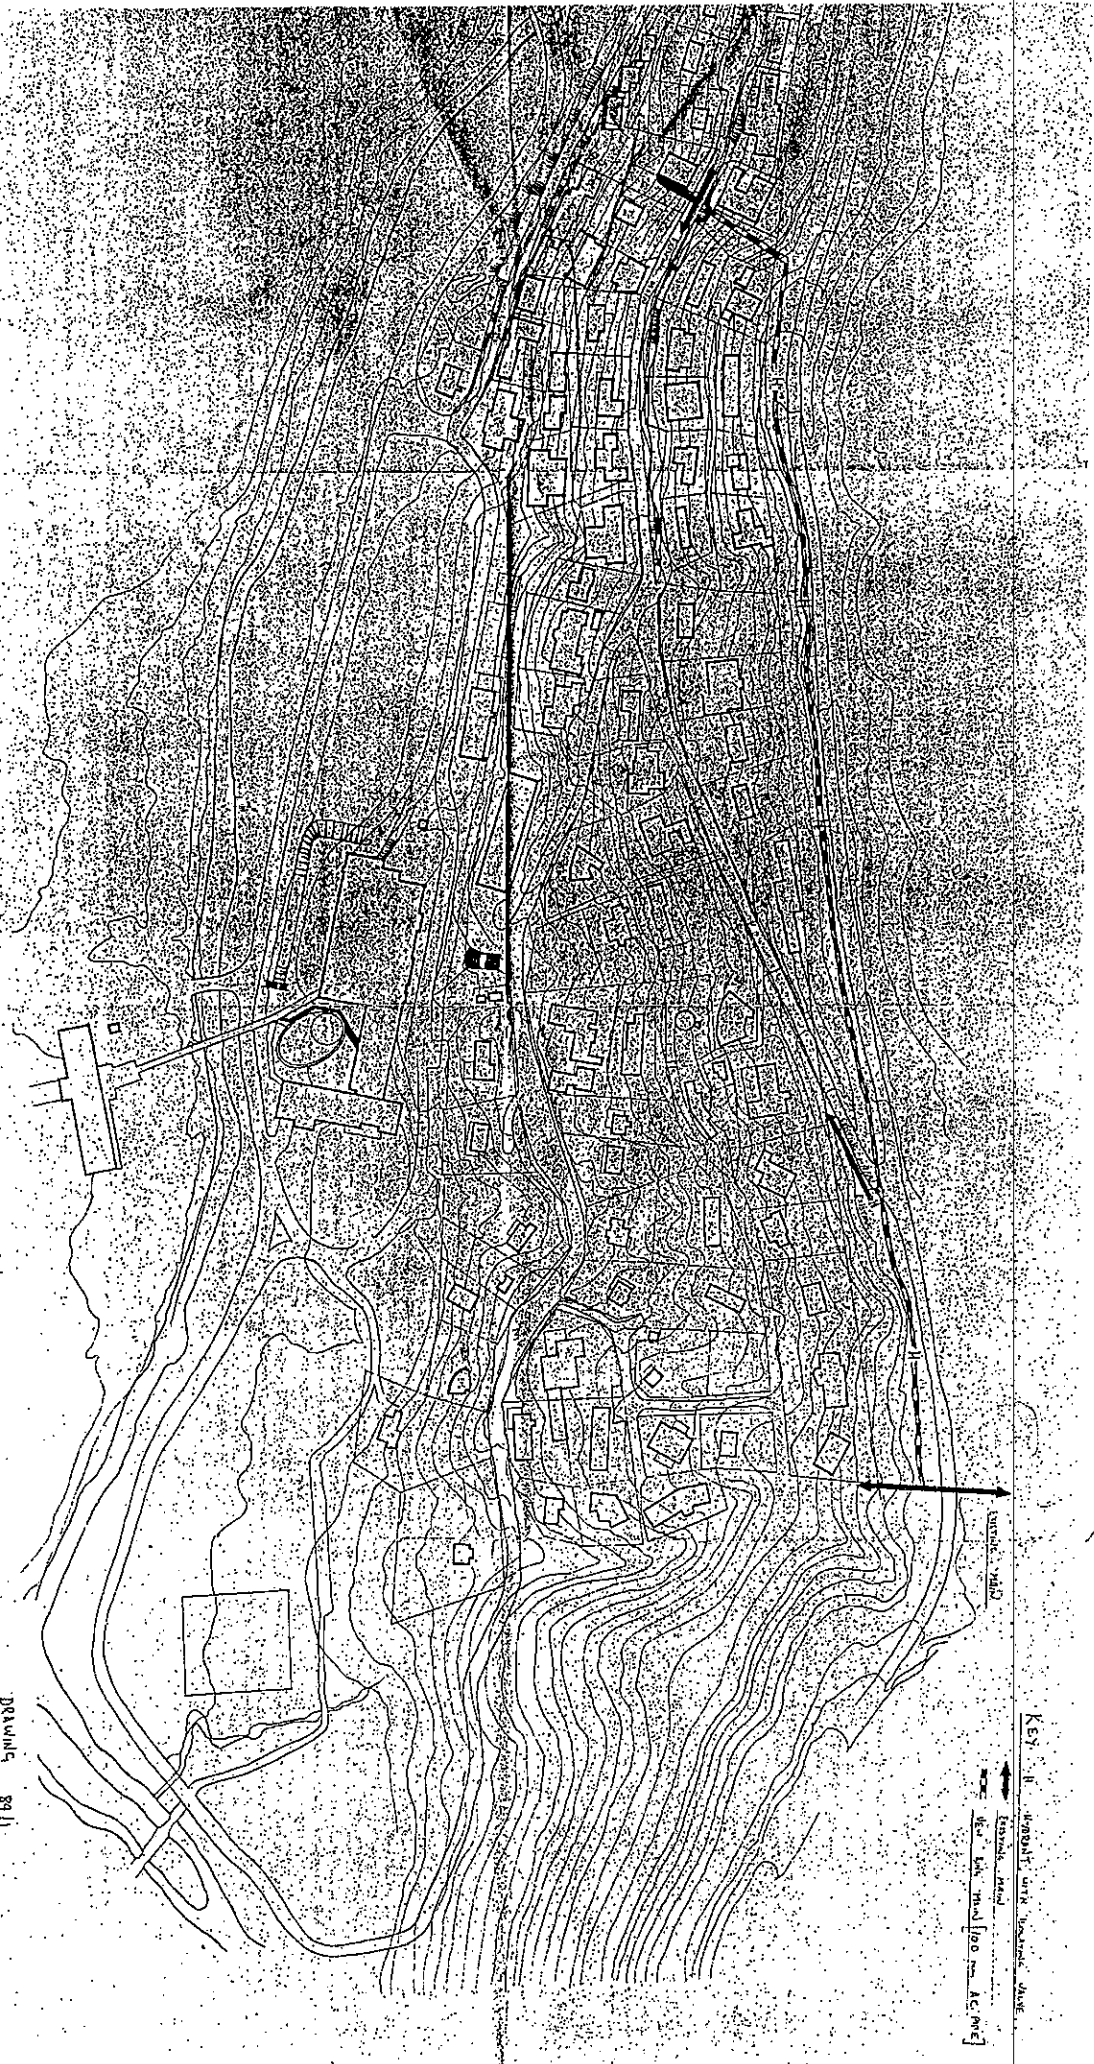
Fig 6. Sketch of Proposed Location of the Watermain

434. There are no extant design drawings or construction drawings for the watermain. There are no as built drawings. Construction commenced in 1984 before any approval was given. A stop work order was issued by NPWS. It is not known for how long the pipeline had been under construction or the extent of construction pre-stop work order. Approval was subsequently given by NPWS and construction proceeded. A drawing is extant showing the pipeline as having an approximate 90 degree bend near to the Schuss-Carina boundary.<sup>2</sup> (see Appendix 10, Figure 6)

449. The plan which was attached to the letter was a contour plan of the Village upon which Mr. McConnell had sketched the proposed new ring main which was identified as a 100mm AC pipe (see Appendix 10, Figure 6). The sketch showed the new ring main extending along the Alpine Way from the western most extent of the Village east to just beyond Schuss Lodge where it turned and ran down between Schuss and Gunyang Lodges on the west and Carinya Lodge on the east. It then appeared to connect with the existing Village water main just above Bimbadeen Lodge in Bobuck Lane.<sup>14</sup>
